CAN-Bus Troubleshooting Guide

1. CAN-Bus Troubleshooting Guide

The CAN-Bus Troubleshooting Guide is a guide to find and eliminate the most frequent hardware-error causes in the wiring of CAN-networks.

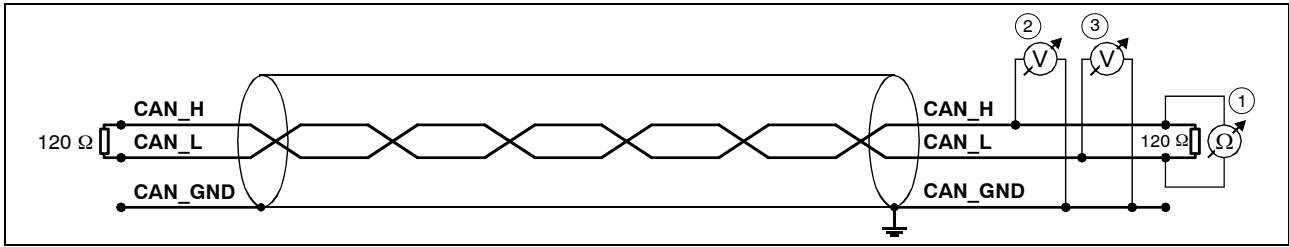
Figure: Simplified diagram of a CAN network

1. Turn off all power supplies of the attached CAN nodes.
2. Measure the DC resistance between CAN_H and CAN_L at the middle and ends of the network (1) (see figure above).

The measured value should be between 50 and 70 Ω. The measured value should be nearly the same at each point of the network.

1. Turn on all supplies.
2. Stop all network communication.
3. Measure the DC voltage between CAN_H and GND **2** (see figure above).
4. Measure the DC voltage between CAN_L and GND **3** (see figure above).

Normally the voltage should be between 2.0 V and 4.0 V.

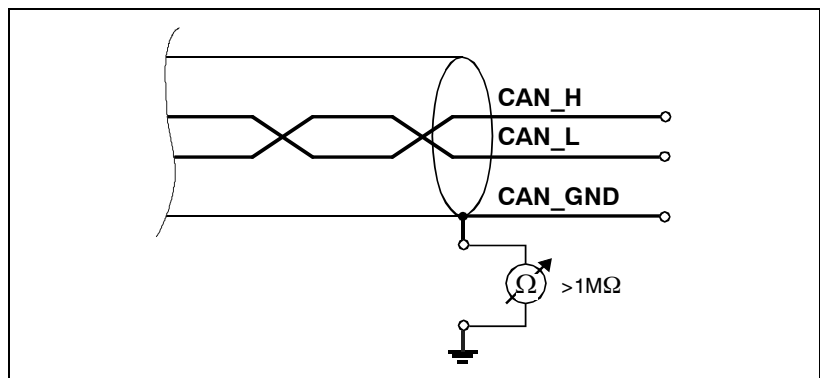
Fig.: Simplified schematic diagram of ground test measurement

The shield of the CAN network has to be grounded at only one location. This test will indicate if the shielding is grounded in several places. To test it, please

1. Disconnect the shield wire (Shield) from the ground.
2. Measure the DC resistance between Shield and ground (see picture on the right hand).
3. Connect Shield wire to ground.

The resistance should be higher than 1 M Ω . If it is lower, please search for additional grounding of the shield wires.

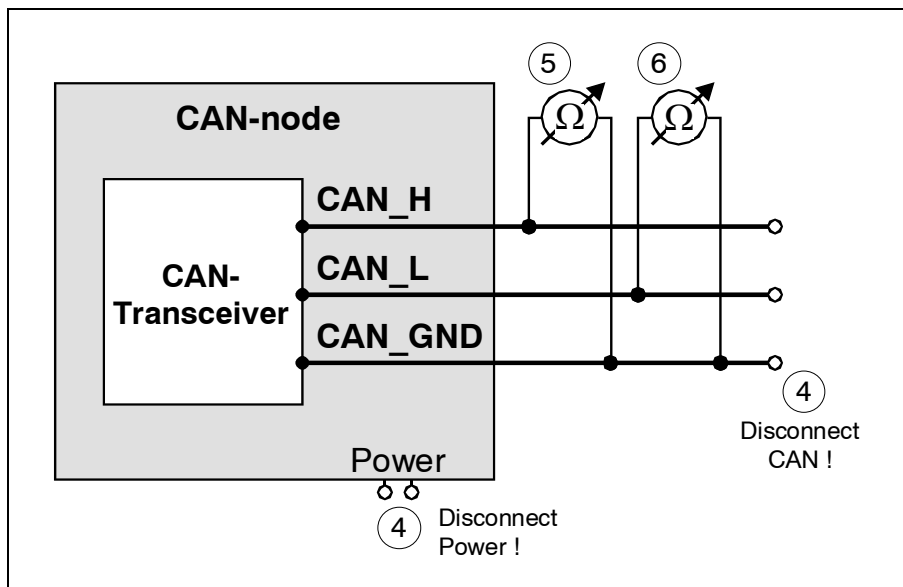
Figure: Simplified diagram of a CAN node

1. Disconnect the node from the network. Leave the node unpowered (4) (see figure below).
2. Measure the DC resistance between CAN_H and CAN_GND (5) (see figure below).
3. Measure the DC resistance between CAN_L and CAN_GND (6) (see figure below).

Normally the resistance should be between 1 M Ω and 4 M Ω or higher. If it is lower than this range, the CAN transceiver is probably faulty.
